# **INDOOR AIR QUALITY ASSESSMENT**

**Petersham Town Office Building  
3 South Main Street  
Petersham, Massachusetts**

Prepared by:  
Massachusetts Department of Public Health  
Center for Environmental Health  
Emergency Response/Indoor Air Quality Program  
November 2004

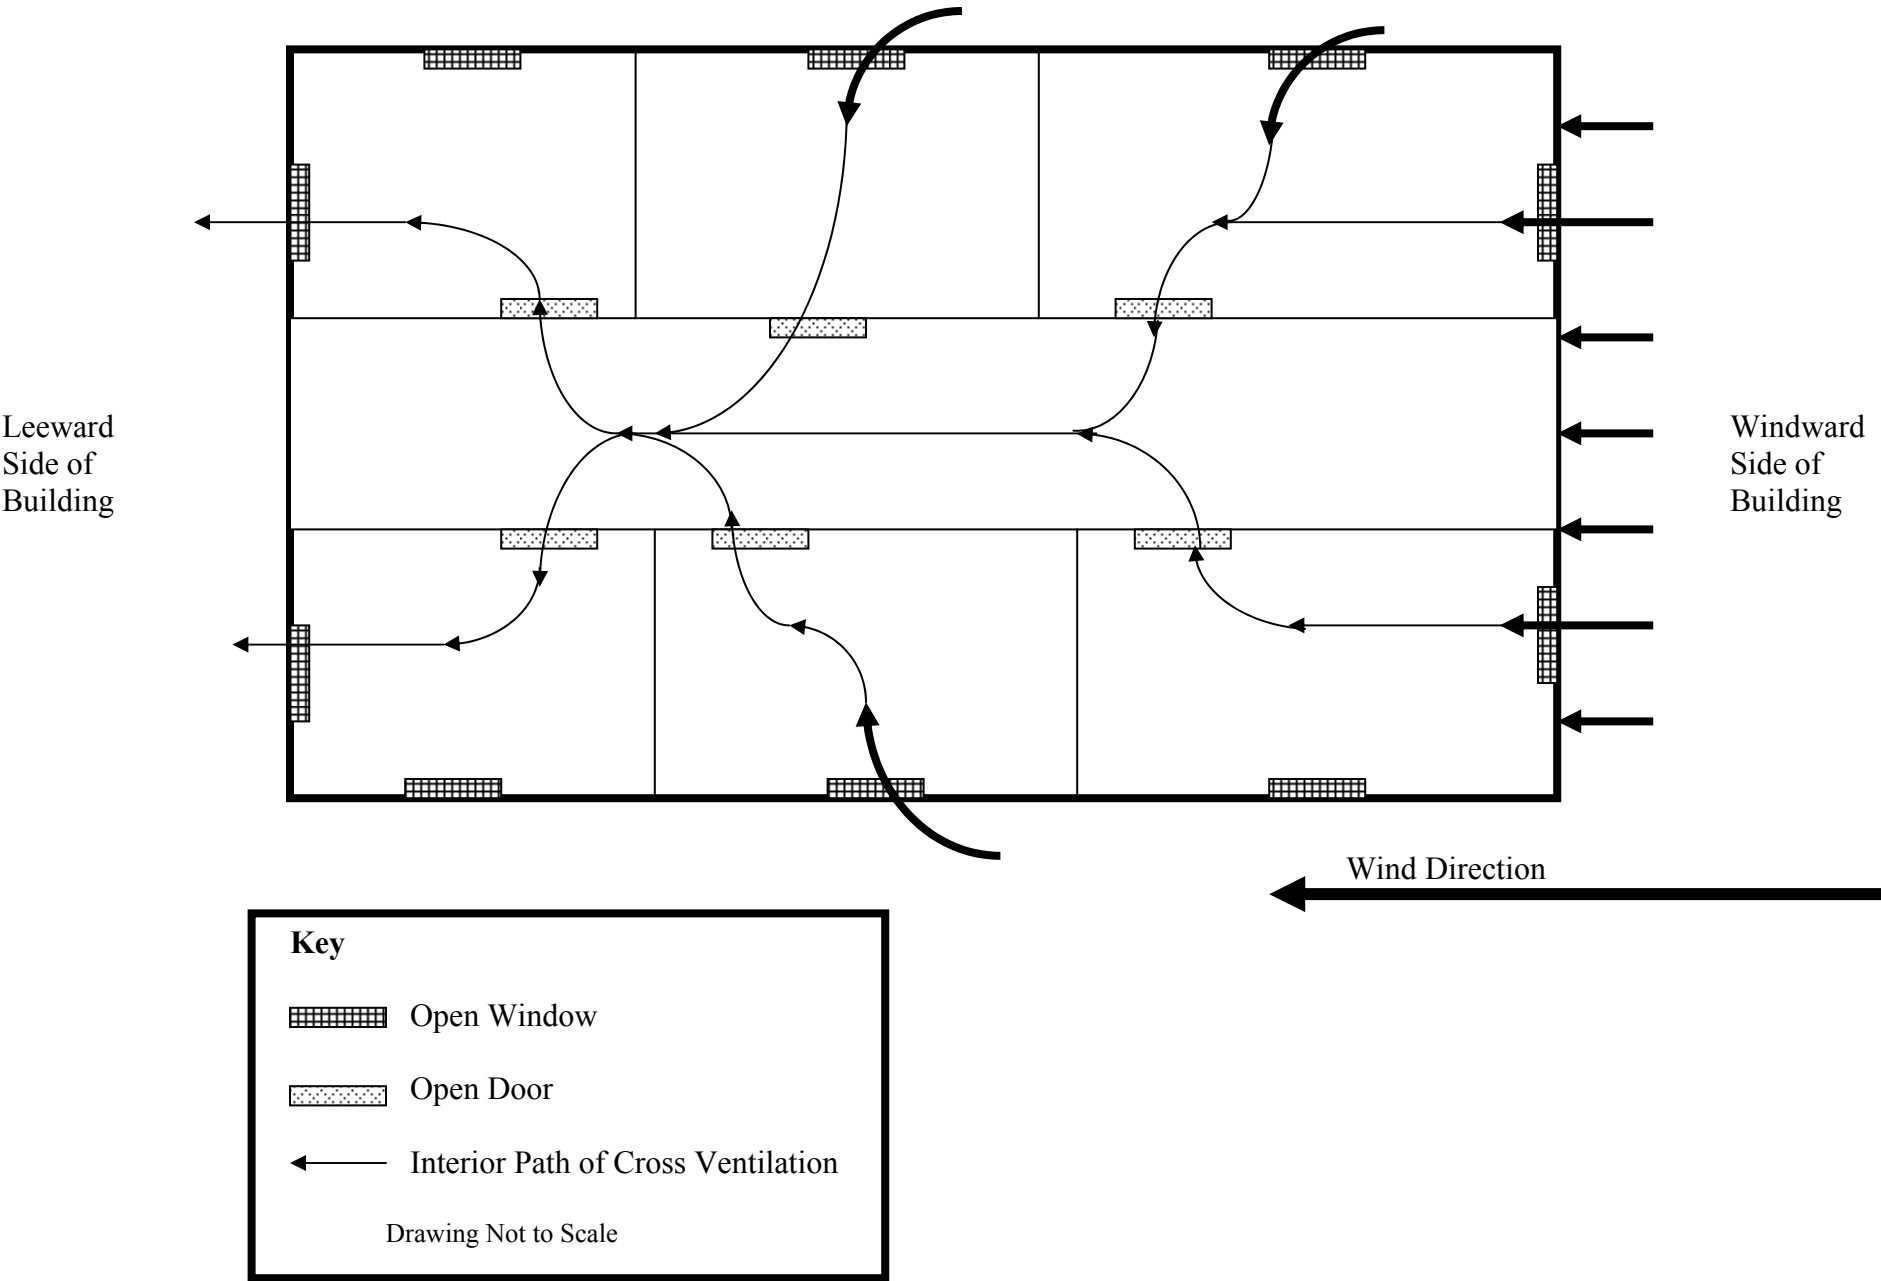
Figure 1

Cross Ventilation in a Building Using Open Windows and Doors

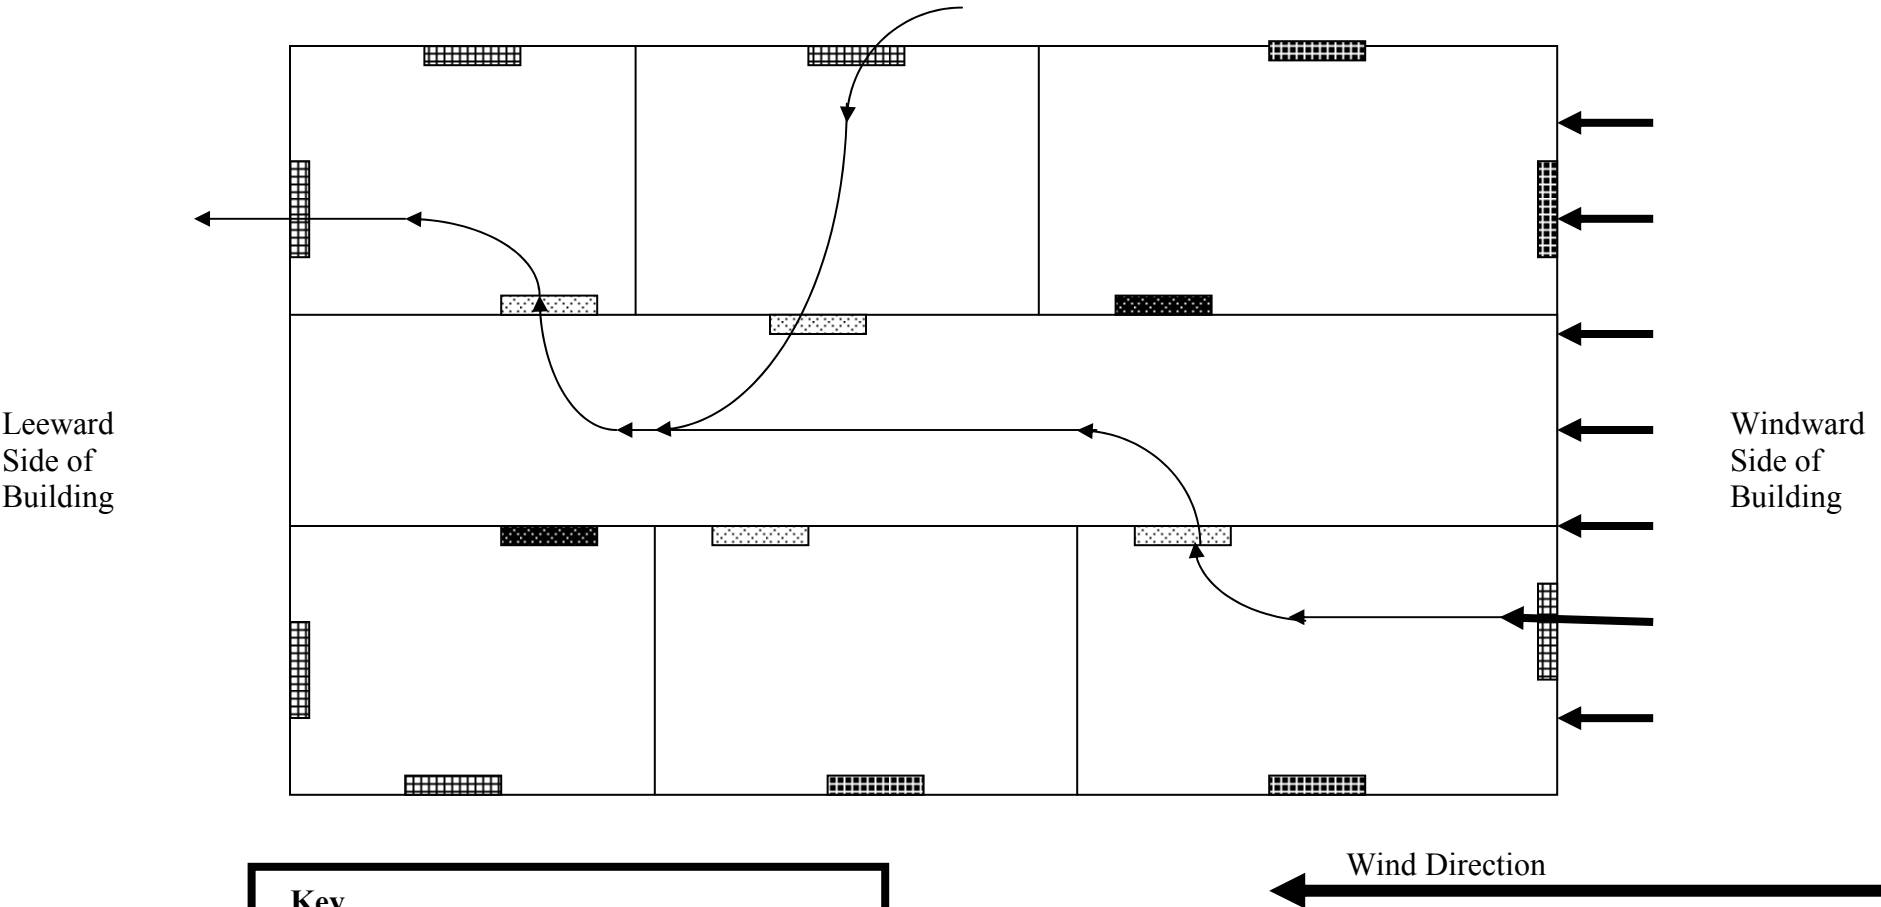
Figure 2

The building was configured in a manner to use cross-ventilation to provide comfort for building occupants. The PTOB is equipped with windows on opposing exterior walls. This design allows for airflow to enter an open window, pass through a room, through the open hallway door, enter the hallway, pass through the opposing room's hallway door, into the opposing room and exit the building on the leeward side (opposite the windward side) (Figure 1). With all windows and hallway doors open, airflow can be maintained in a building regardless of the direction of the wind. The system fails if the windows or hallway doors are closed (Figure 2).

Inhibition of Cross Ventilation in a Building with Several Windows and Doors Closed

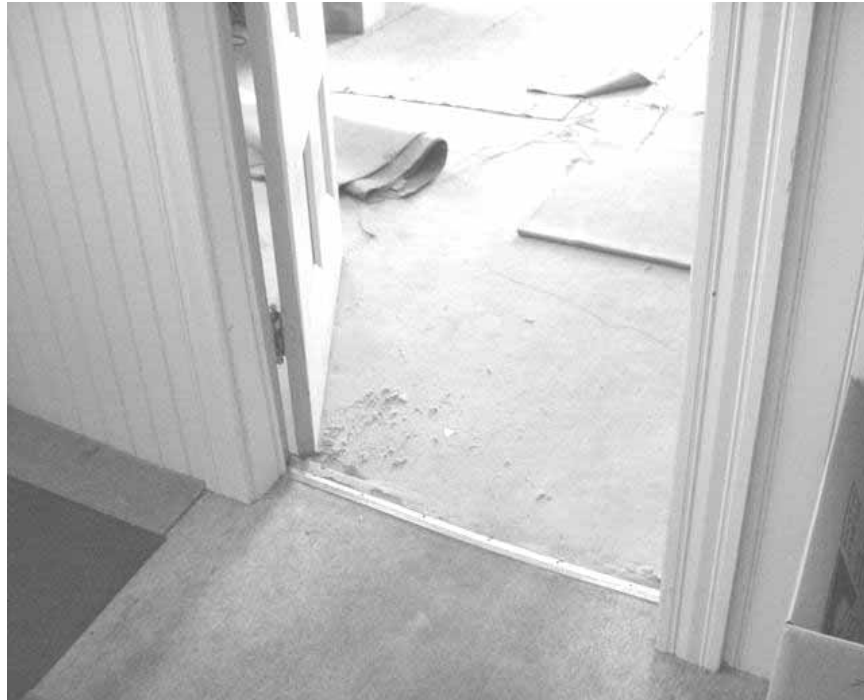
**Picture 1**

During the course of the assessment, building occupants expressed concerns about mold in the town selectmen's office. The floor of the selectmen's office was covered with wall-to-wall carpet installed on a foam rubber pad (Picture 1). An odor was detected in this area of the floor.

The building was evaluated on a sunny day, with an outdoor temperature of 74 ° F and relative humidity of 65 percent. No active leaks were observed and no visible moisture was noted on walls. Relative humidity indoors was measured at 60 percent in the town selectmen's office (Table 1). Moisture measurements taken through the carpet to the wooden floor ranged from 16 to 45 percent. These measurements indicate that the wood surface below the foam rubber was moistened. This condition is likely attributable to the installation of the carpet and more importantly, the foam rubber pad on the floor. In this instance the foam rubber pad was glued to the floor, creating a vapor barrier which prevented air and water vapor movement. Without air and water vapor movement, the floor slats cannot dry since moisture is trapped between the foam rubber pad and underlying floor.

**Wall-To-Wall Carpet Installed on a Foam Rubber Pad in Selectmen's Office**

1. Remove carpet and padding from the selectman's office.
2. Clean residue from floor beneath carpet and allow to air dry. Once dry, refinish the floor during temperate weather.
3. Remove rotten timber and other accumulated debris from the basement.
4. Install weather stripping and a door sweep on both the attic and basement doors to limit air movement into occupied areas.
5. To prevent moisture penetration into the basement, the following actions should be considered:
  - a) Extend downspout and reestablish the grade of the tarmac apron to drain rainwater from the foundation.
  - b) Seal the crack in the foundation on the southwest corner of the building and the spaces on the western and southern exterior walls between the foundation/tarmac junctions with an appropriate sealing compound.

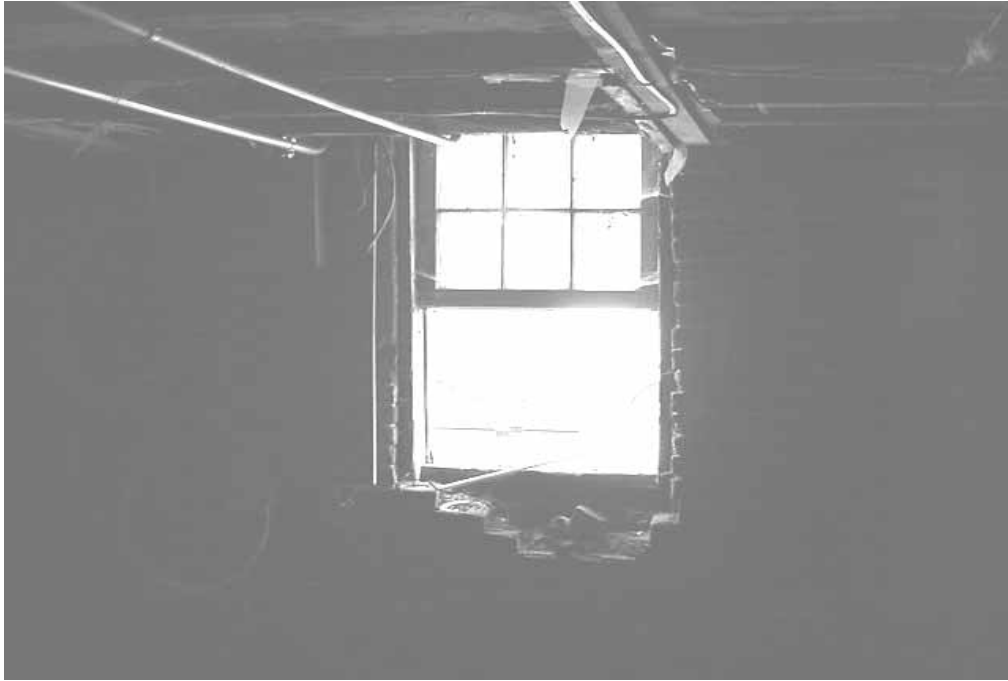
**Picture 2**

Moisture is introduced into the interior of the PTOB through basement windows that are opened in the summer (Picture 2). As relative humidity levels increase indoors, porous building materials, such as wood and carpeting, can absorb moisture. The moisture content of wood and carpeting can fluctuate with increases/decreases in indoor relative humidity. In an effort to ascertain moisture content of carpeting and the underlying floor, a Delmhorst probe was inserted into the surface of carpet, through the padding and into the surface of the town selectmen's office

- According to town selectmen, the windows in the basement are opened in the spring and closed in the fall to provide ventilation for the basement. This practice may have increased water damage in the basement due to the excessively hot, humid weather that persisted in Massachusetts for more than 14 days during the month of August 2003 (The Weather Underground, 2003). This hot, humid weather would tend to wet

**Open Window to Air out the Basement during Warm Weather**

1. In order to aid in the prevention of water vapor accumulation in the basement, consideration should be given to installing a low speed exhaust fan in one of the basement windows. The fan should be operated during hot, humid weather to exhaust water vapor and draw dry air from the upper occupied levels during summer months.
2. To provide insulation during the winter, consult a building engineer on the appropriate method to insulate the floor to prevent moisture accumulation.

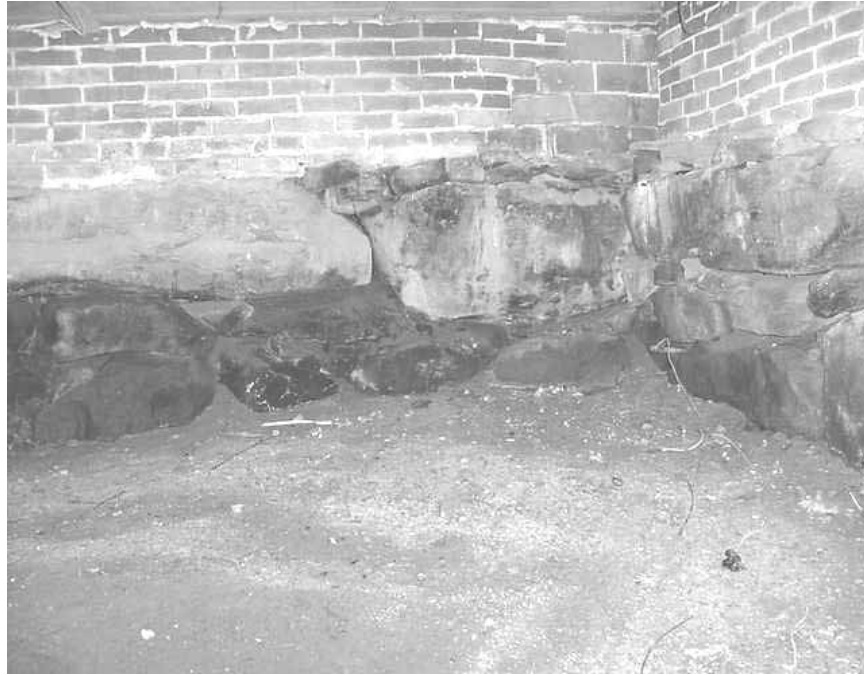
**Picture 3**

towards New England (Trewartha, G.T., 1943). Wet weather systems generally produce south/southwesterly winds, which will expose the south and west facing walls to driving rain on a consistent basis, unlike the east and north walls. The basement consists of flagstone walls (Picture 3) with a dirt floor, which would allow accumulated surface water (pooling rain) on the exterior of the building to readily enter the basement. In order to prevent rainwater accumulation against the flagstone foundation, a tarmac apron was installed along the south and west walls. Over time, the apron has separated from the granite sill of the building, creating a seam on the west wall (Picture 4). In addition, a crack has formed in the corner of the west/south walls (Picture 5). The south wall base has a similar apron that is overgrown with grass and other plants. Over time, the south wall apron has become undermined and is sloped towards the building (Picture 6), which directs rainwater to pool in the foundation/ tarmac seam which subsequently penetrates into the basement the its wall. An additional water source in this general area is a downspout at this corner, which empties at the southwest corner of the building onto the tarmac. The effects of increased water penetration into the southwest corner is demonstrated by extensive repairs to rotted floor pillars and beams in the basement in this corner pf the PTOB area.

**The Flagstone Walls of the Basement**

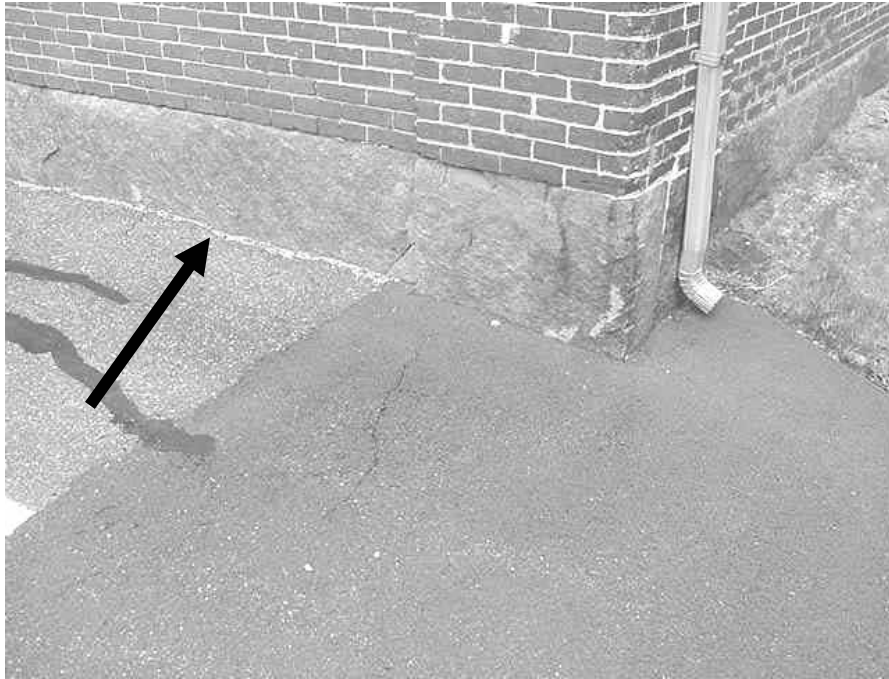
**Picture 4**

**Seam between Apron and Granite Sill of the South Exterior Wall**

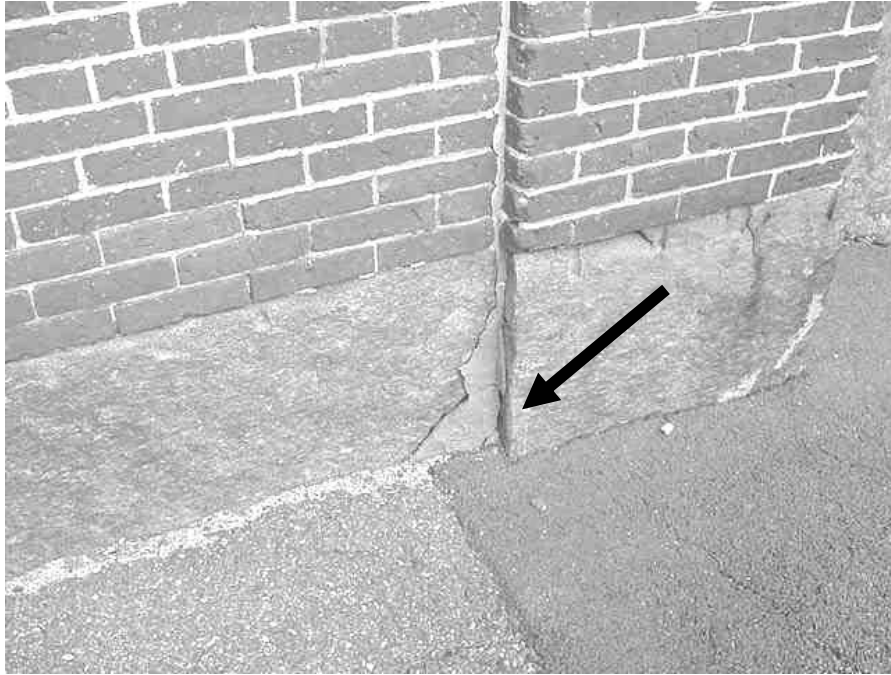
**Picture 5**

**Crack at the Corner of the South Exterior Wall**

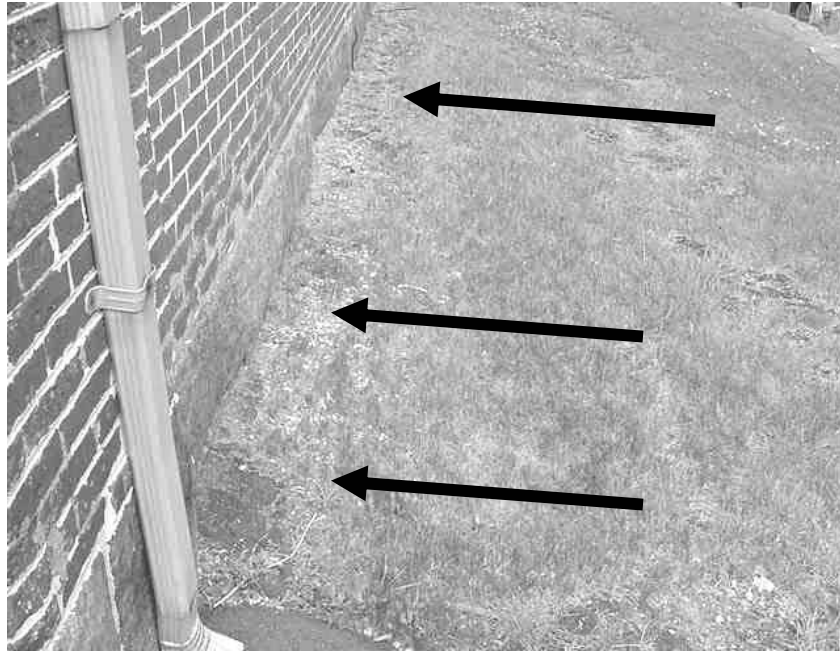
**Picture 6**

**Buried South Exterior Wall Apron Sloping Towards the Building**

- c) Remove foliage to no less than five feet from the foundation.
  - d) Improve the grading of the ground away from the foundation at a rate of 6 inches per every 10 feet (Lstiburek, J. & Brennan, T.; 2001).
